# Design, Material, and Manufacturing Factors That Affect the Fixation of Metallic Implants to Bone: Evidence from Total Knee Replacements

Aarti Shenoy<sup>1</sup>, Elexis Padgett<sup>1</sup>, Sarah Hymowitz<sup>1,2</sup>, Timothy Wright<sup>1</sup>  
<sup>1</sup>Department of Biomechanics, Hospital for Special Surgery, New York NY  
shenoya@hss.edu

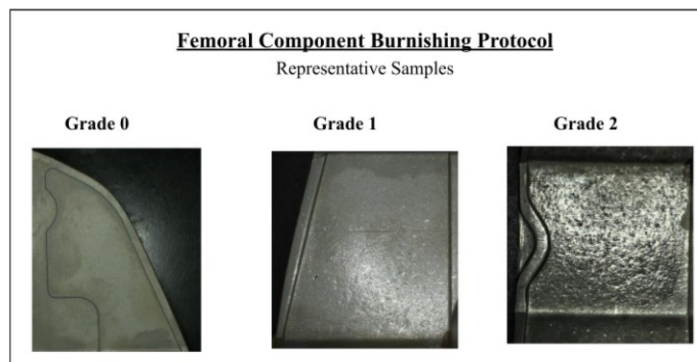
Figure 2 – Burnishing grades representative images indicating grade 0: no burnishing, grade 1: minor burnishing, grade 2: moderate burnishing
