Enhanced Tribocorrosion Resistance of 3D Printed Ti- Implants: PVD multilayer coating on PEO-Treated Surface

Marzieh Ebrahimi^{1,2}, Ahmad Kermanpur¹, Mahshid Kharaziha¹, Mareeswari Paramasivan², Hesam Rezvani Sichani¹, Mathew T. Mathew²

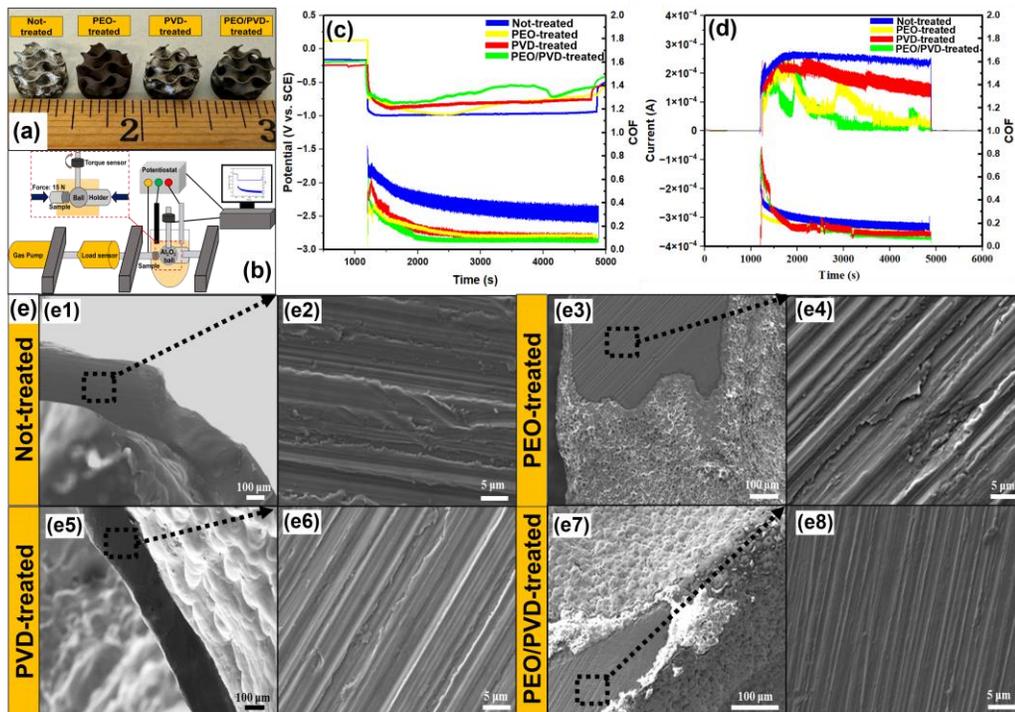
Figure: 1a) The LPBF Ti-6Al-4V porous implants with different surface modifications. **b)** Hip simulator schematic, **c)** OCP and COF curves of samples during sliding in BCS at 37°C, **d)** Current and COF curves of samples during sliding in BCS at 37°C, **e (e1-e8))** SEM images of worn area after tribocorrosion test.

METHODS: Ti-6Al-4V porous implants with gyroid structure were designed and fabricated via laser powder bed fusion (LPBF). Based on our previous work⁵, the implants were treated with PEO and then coated with a multilayer Nb/NbN film using PVD (**Figure 1a**). The tribocorrosion test was conducted using a hip simulator system⁶ (**Figure 1b**). Samples were loaded against the alumina (Al₂O₃) ball, rotated ±30° in an oscillatory pattern in the bovine-calf serum (BCS, 30 g/L of protein concentration) under the normal load of 16±1 N (to achieve the contact pressure of 50 MPa). The test was performed with a frequency of 1 Hz for 3600 s. Tribocorrosion tests were performed under open circuit potential (OCP) and potentiostatic (PS) conditions. For the PS tests, the potential value of -0.1 V was applied. The wear-corrosion synergistic analysis was done, as per Stack's approach; $K_{wc} = K_w + K_c$, where K_{wc} , K_w , and K_c represent the total weight loss of material due to tribocorrosion wear, and corrosion, respectively⁷. The worn surfaces were examined by scanning electron microscopy (SEM, JOEL, MA, USA).

RESULTS: The PEO/PVD-treated samples demonstrated increased tribocorrosion performance under OCP conditions, evidenced by a lower potential drop and coefficient of friction (COF) value (**Figure 1c**). Moreover, the PEO/PVD treatment reduced corrosion current and COF of samples during the tribocorrosion test under PS conditions, which indicates higher tribocorrosion performance and the anti-friction performance of the coatings (**Figure 1d**). The total weight loss of material due to tribocorrosion (K_{wc}), wear (K_w), and corrosion (K_c) for PEO/PVD-treated was lower than that of others. Lower K_w value obtained for PEO/PVD-treated was related to their higher wear resistance. The K_c values of all samples were significantly lower than the K_w values, indicating minimal effect of corrosion in the synergistic degradation process. All samples exhibited abrasive and adhesive wear mechanisms based on the SEM images of the worn surface after tribocorrosion. The grooves were shallower and narrower for PEO/PVD-treated samples, indicating their higher wear resistance than others. However, both PVD-treated and PEO/PVD-treated samples exhibited the coating delamination mechanism (**Figure 1e**).
